Church Chancel Saved!

ST. PAUL'S, WOODHOUSE EAVES CHANCEL REPAIR AND HERITAGE PROJECT

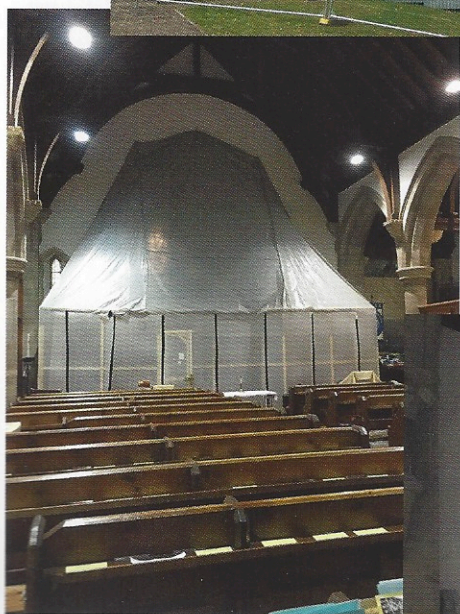
PHOTOS: top to bottom

The scaffolding arrives in August

The scaffolding and protective sheeting and fencing in situ around the chancel

Plastic "canopy" protecting body of church from dust

The Chancel as a work site

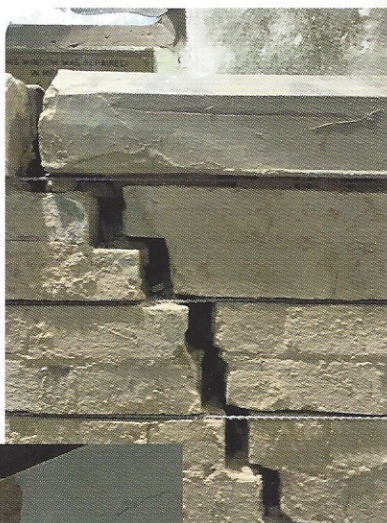
The crack below window with wires to be mortared in for strength

Surprisingly, the work to prevent further subsidence was carried out above ground rather than below. Channels were bored through the walls and steel poles in the form of "Cintec Anchors" installed to prevent further subsidence (... this technology has also been used on a pyramid so we are in good company)! Stainless steel "straps" to the main body of the church are now supporting the wooden beams of the chancel roof, and the Cintec anchors are doing the same thing for the walls. No further movement of the chancel should occur as a result of these new additions.

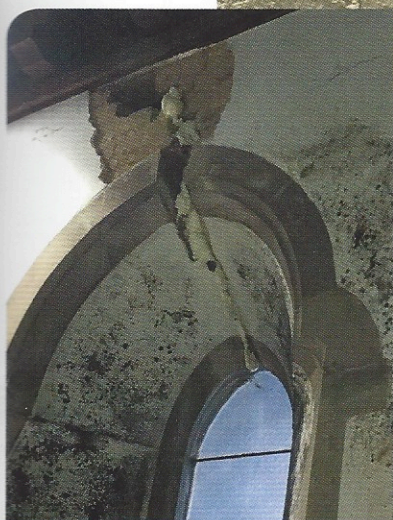
Mould and the crack above a Chancel window

Needless to say, during the repair works the church has been filled with dust. The large patches of mould that appeared on the chancel walls following water damage sustained during the drilling of the channels in the walls were very dramatic and very alarming, but fortunately redecoration has removed all evidence of them. The plastic sheeting "tent" used to protect the body of the church from the worst of the dirt, damp and cold was pretty successful, despite requiring repair after a large lump of plaster tore part of it down early on! The scaffolding is down and the chancel has dried out. The Cintec anchor points are all hidden under stone plugs and the floor tiles are nearly all laid.

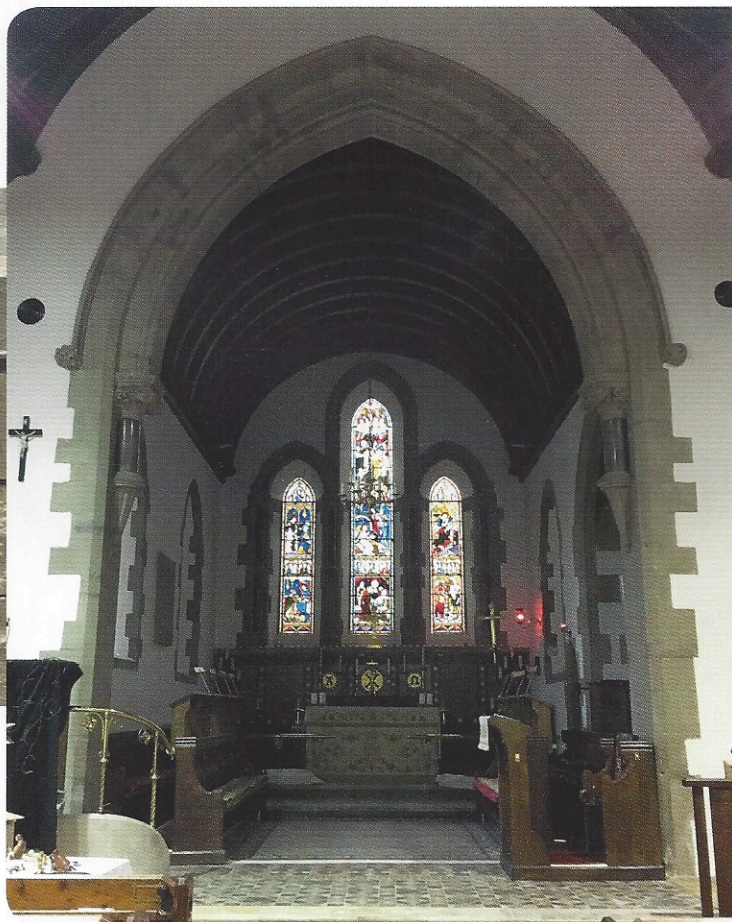
The restored Chancel once again in use in December
